SONOMA DEVELOPMENT CENTER
15000 Arnold Drive
Eldridge
Sonoma County
California

HALS CA-26
CA-26

WRITTEN HISTORICAL AND DESCRIPTIVE DATA

HISTORIC AMERICAN LANDSCAPES SURVEY
National Park Service
U.S. Department of the Interior
1849 C Street NW
Washington, DC 20240-0001

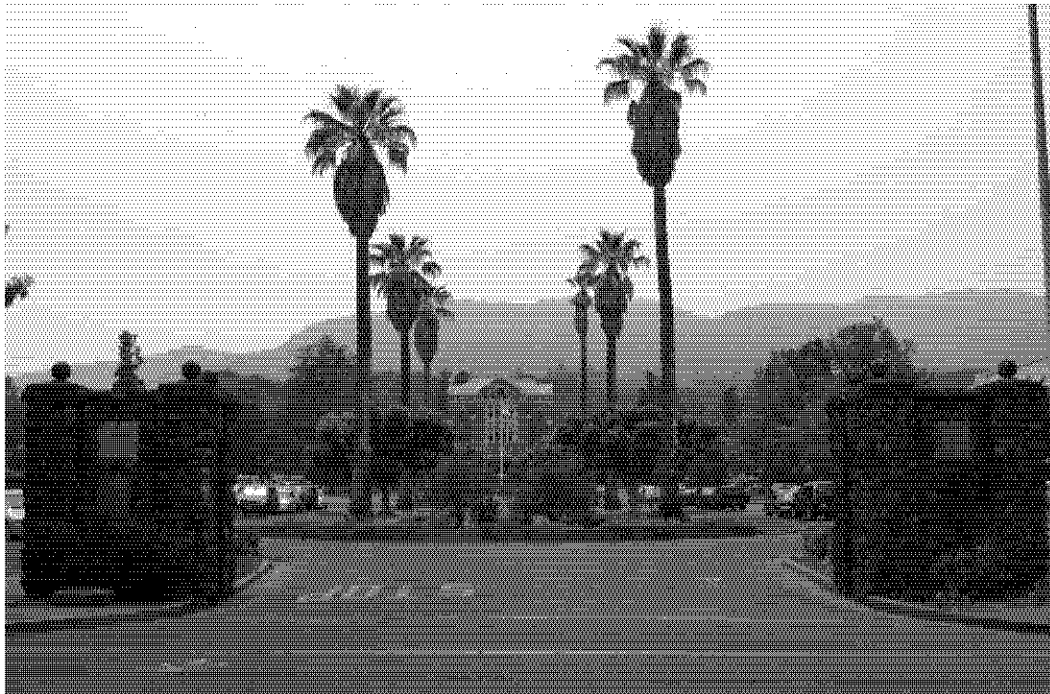
The main entrance to the Sonoma Developmental Center, showing the historic stone entry posts, tree plantings, and the National Register-listed Main Building at the terminus of Harney Circle. This entry and Arnold Street, perpendicular to it and shown in the photo, display the strong formal character of the main entry approaches (Janet Gracyk, June 26, 2008).

Harney Avenue is the main entry point into the Center. It crosses Arnold Drive at right angles and is the main approach to the administrative part of the site. The historic Main Building, now vacant but still known as the Professional Education Center (P.E.C.), is the oldest institutional building on the site (1908) and is dramatically located on axis with the parkway and commands the view of those entering the site. (This building is on the National Register of Historic Places.) Along with the appearance of Arnold Drive through the Center, the relationship of the Main Building to the road sets up the character of the site. This western section of Harney Avenue is split by a generous parkway which is planted with pairs of palms alternating with pairs of pollarded sycamores. This very strong entry statement is clearly visible on a 1910 postcard; now the pattern is not quite complete since some palms are missing. It appears that the opposite sides of the street may have been planted with regularly spaced gingko trees, some trees remain on the northern side of the street.

The intersection with Arnold is marked with large stone columns, stone planter/seal walls, and a rustic-style, stone bus shelter. The gates and walls are visible in a 1910 postcard, the bus shelter location is out of view of the camera, but it is stylistically compatible with the columns and walls and may date from the same period of construction. This style is very sympathetic to the historic-revival architecture styles used throughout the site.

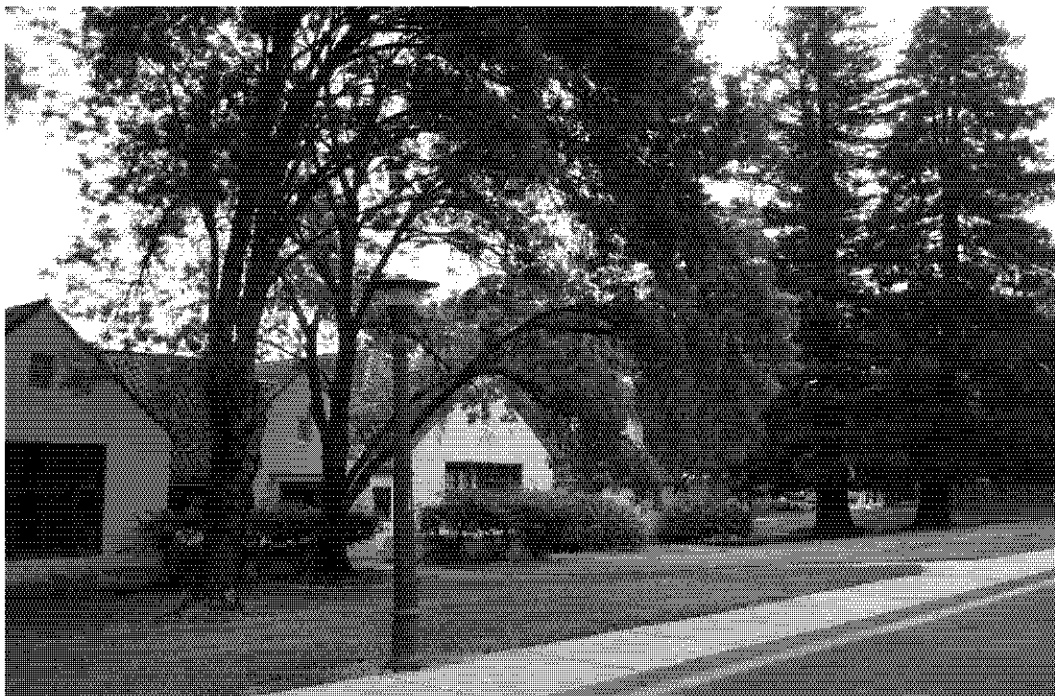
A characteristic cottage is displayed on the right with mature trees, generous lawns, and the residential scale and informal character that was used throughout the resident areas in the 1920s and 1930s (Janet Gracyk, June 3, 2008).
